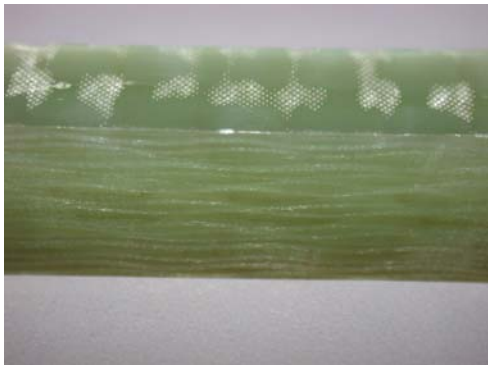
woven fabric S2-glass fiber reinforced vinyl ester composite

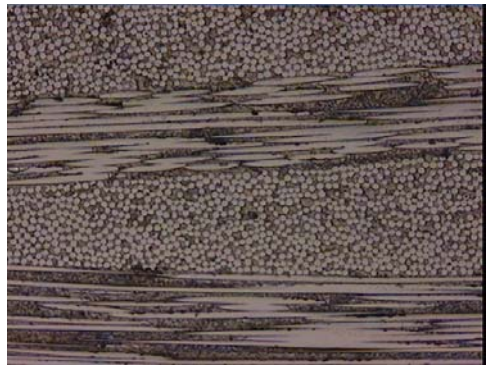
woven fabric S2-glass fiber reinforced vinyl ester composite

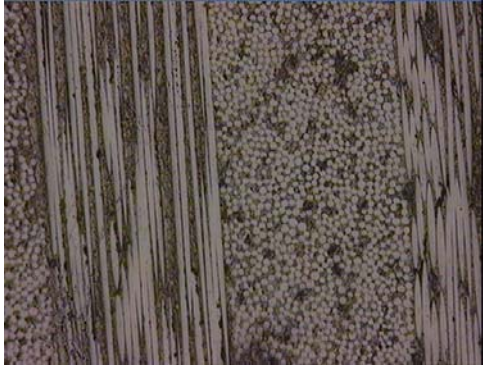
woven fabric S2-glass fiber reinforced vinyl ester composite

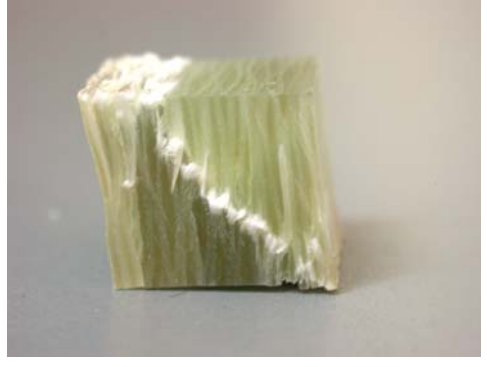
compression tested woven fabric S2-glass fiber reinforced vinyl ester composite

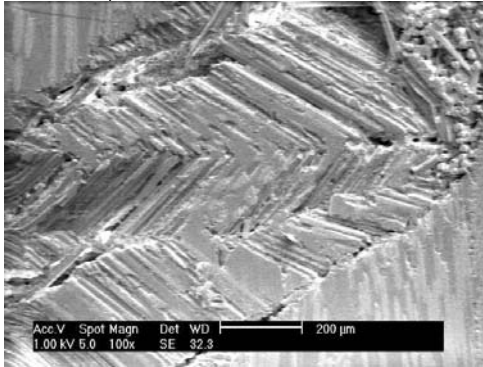
compression tested woven fabric S2-glass fiber reinforced vinyl ester composite

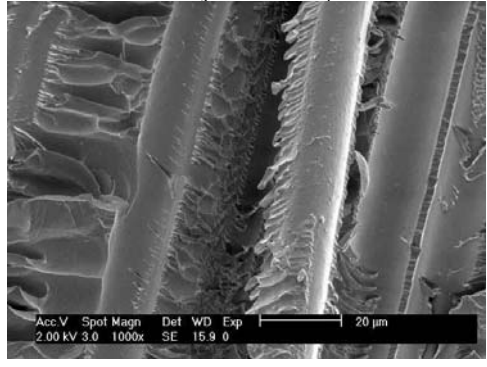
Fracture surface of the woven fabric S2-glass fiber reinforced vinyl ester composite

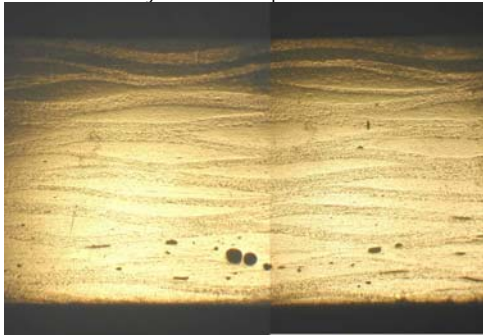
plain-weave S-2 glass fabric SC-15 epoxy composite

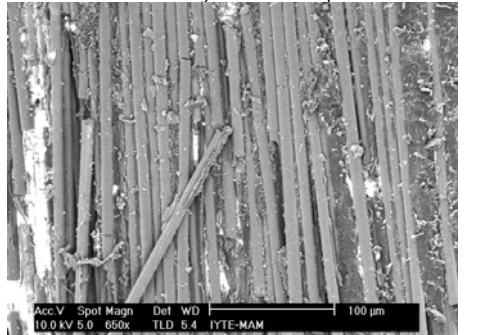
Fracture surface of the plain-weave S-2 glass fabric SC-15 epoxy composite

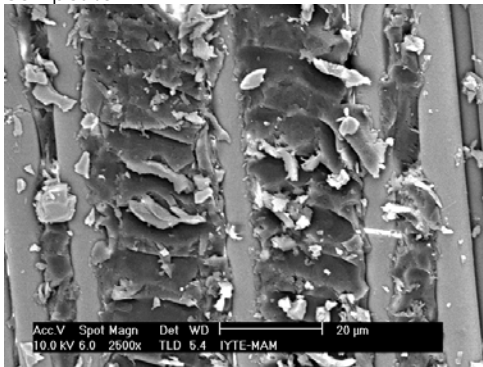
Fracture surface of the plain-weave S-2 glass fabric SC-15 epoxy composite

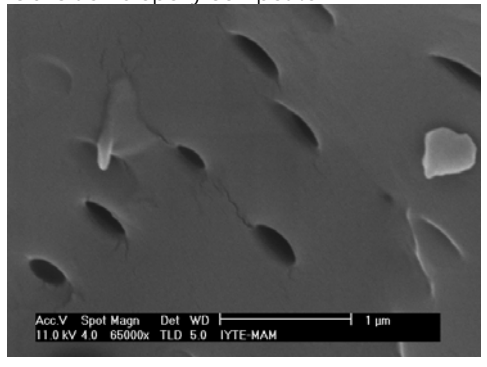
Fracture surface of the plain-weave S-2 glass fabric SC-15 epoxy composite, showing rubber particles
